**July 2000**

# **MAINTENANCE BULLETIN**

**Alfa Company**

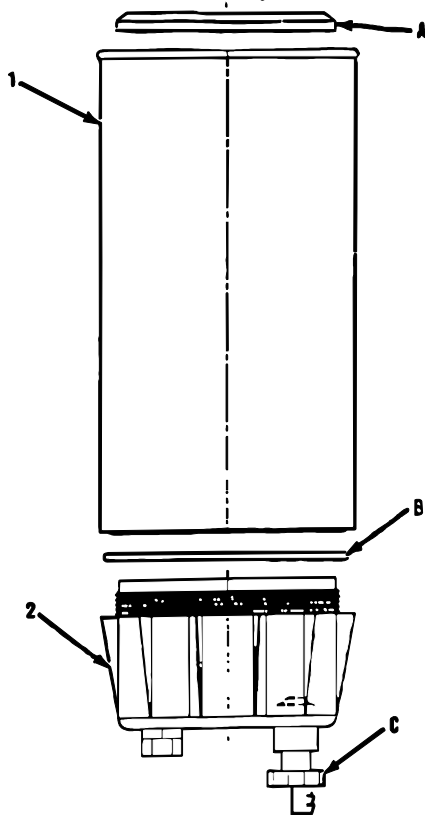
Components of the 129-0372 Primary Fuel / Water Separator

The 3408E and 3412E Engines in these machines are equipped with a 129-0372 Primary Fuel Filter/Water Separator Assembly. See the illustration. The primary fuel filter/water separator assembly consists of a 129-0373 Element and a 129-0375 Bowl. The element includes the larger upper beveled seal (A) and the smaller lower seal (B). The bowl includes the smaller lower seal (B).

The water from the fuel accumulates in the bowl. Drain valve (C) is part of the bowl. The drain valve allows any water that accumulates in the bowl to be drained. If the water is not drained when the bowl becomes full, an increased resistance to fuel flow will result.

Assembly. 129-0373 Element (1). 129-0375 Bowl (2). Larger upper beveled seal (A). Smaller lower seal (B). Drain valve (C).

- o Every 10 hours of operation or daily, drain the water separator bowl and drain water and sediment from the fuel tank.
- a Every 500 hours of operation or every three months, replace the primary fuel filter/water separator element (use a 129-0373 Element).

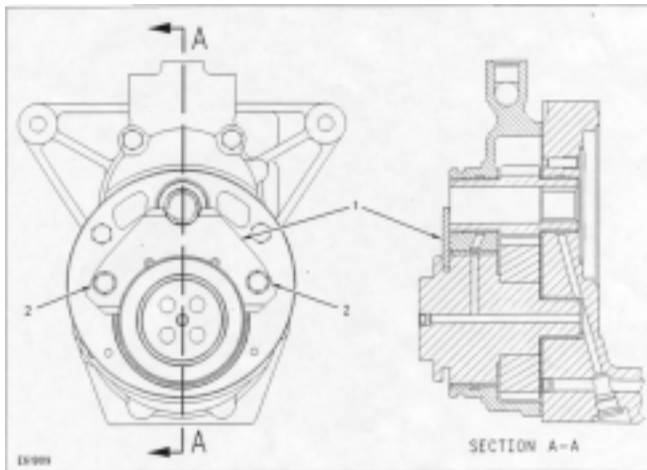
**Description Of Change:** A new steel thrust plate is used in the Hydraulically Actuated Electronically Controlled Unit Injector (HEUI) pump drive groups on the 3408E (99C) and 3412 (80M) Engines in these machines. The new steel thrust plate provides greater strength to resist breakage in high load applications. A broken thrust plate can result in the loss of the speed-timing signal.

Location of the new 150-2392 Thrust Plate and 9N-0869 Washers in the HEUI Pump Drive Groups.

**Adaptable To:** The new 150-2392 Thrust Plate (1) and 9N-0869 Washers (2) replace the former 124-6639 Thrust Plate and 9M-1974 Washers in the 125-3427 and 125-3430 HEUI Pump Drive Groups on 3408E (99C) and 3412E (80M) Engines respectively. The former 124-6639 Thrust Plate is canceled.

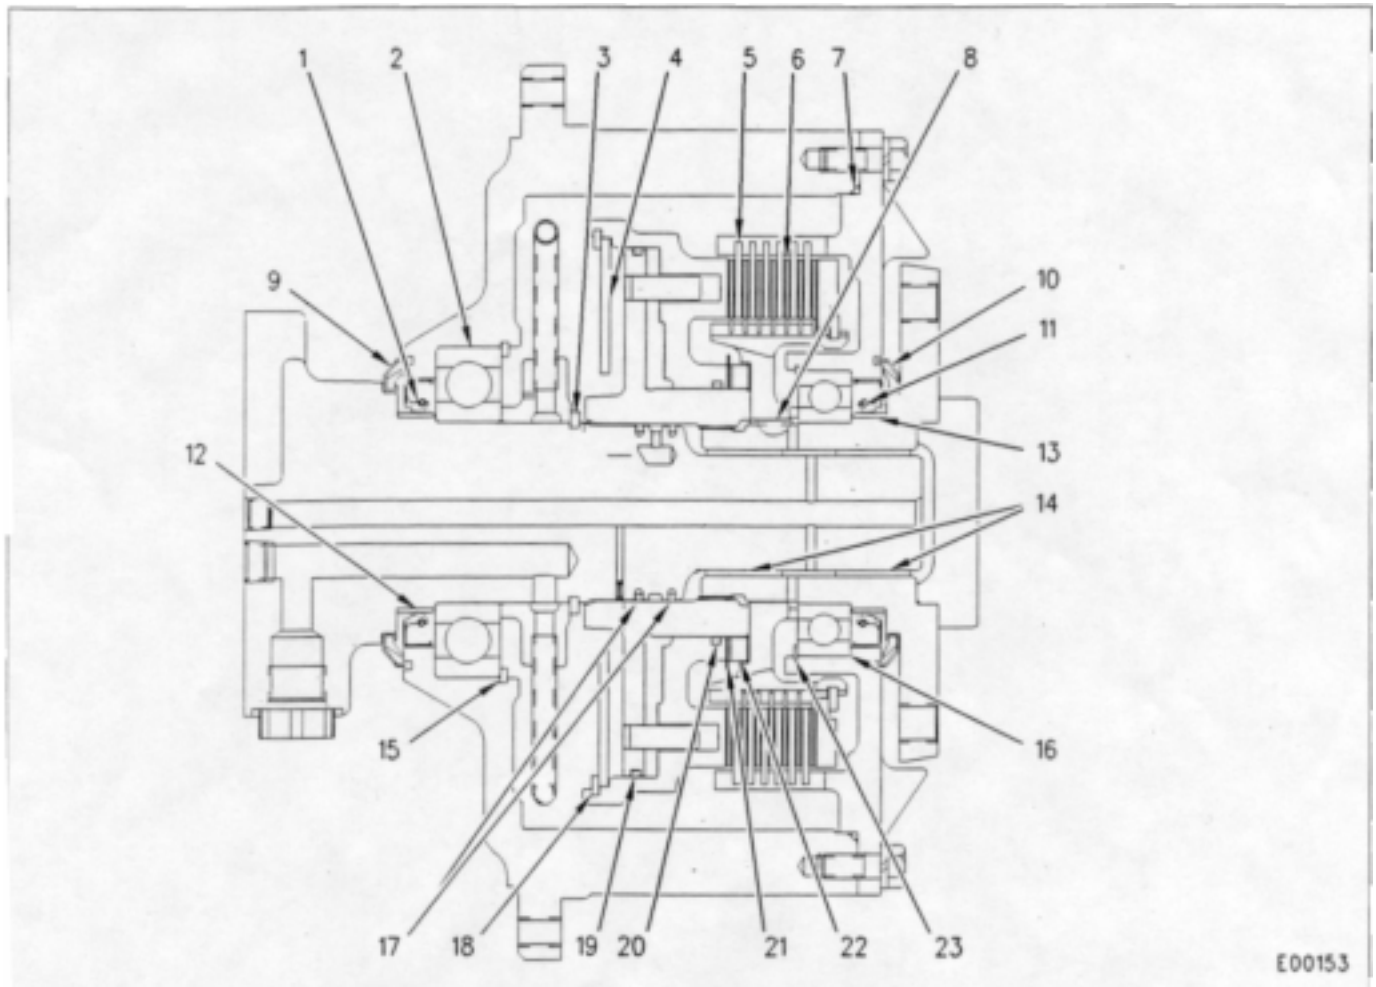
Identification of fan drive group seal kit and overhaul kit components.

The wear sleeve identified by the blue mark on the inside diameter must be installed at the rear of the clutch shaft. The wear sleeves must be installed in the correct positions to prevent external oil leaks.

The wear sleeve identified by the red mark on the inside diameter must be installed at the front of the clutch shaft. The wear sleeves must be installed in the correct positions to prevent external oil leaks.

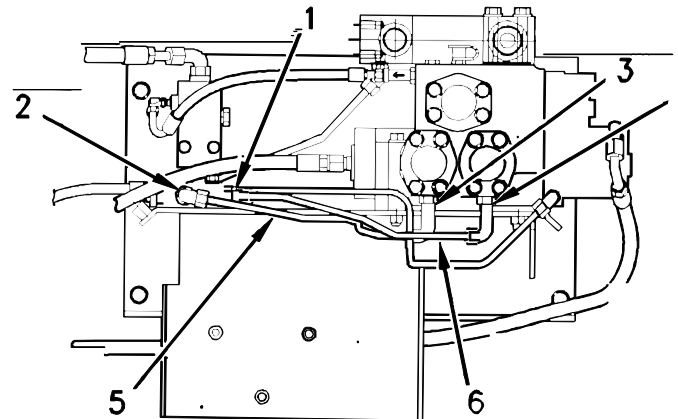
### Illustration 1

**Description Of Change:** Improved hoses are now used on the 988F Series II Wheel Loader steering control. The new hoses provide a longer service life and better serviceability. The new hoses are effective with 988F Series II (PIN: 2ZR2014-Up) Wheel Loaders.

(1) 6V - 9001 Elbow. (2) 6V - 8724 Elbow. (3) 8T - 1 905 Elbow. (4) 8T - 1905 Elbow. (5) 127 - 4962 Tube. (6) 127 - 4963 Tube.

2. Remove 127-4962 Tube (5) and 127-4963 Tube (6).

3. Remove 8T-1 905 Elbow (3). Replace 8T-1905 Elbow (4) with a 3J-1907 Seal and a 7W-7381 Outlet Fitting. Attach a 6V-8724 Elbow with a 6V-8397 O-ring Seal and a 3J-1907 O-ring Seal to the 7W-7381 Outlet Fitting.

4. Install 6V-8636 Seal Adapter (7) with a 3J - 1907 O-ring Seal and a 6V-8397 O-ring Seal. Install 178-7981 Hose Assembly (8). Install 178-7981 Hose Assembly (9).
